FAILURE OF THE FIRST CARSINGTON EARTH EMBANKMENT DAM IN THE UNITED KINGDOM

SUMMARY

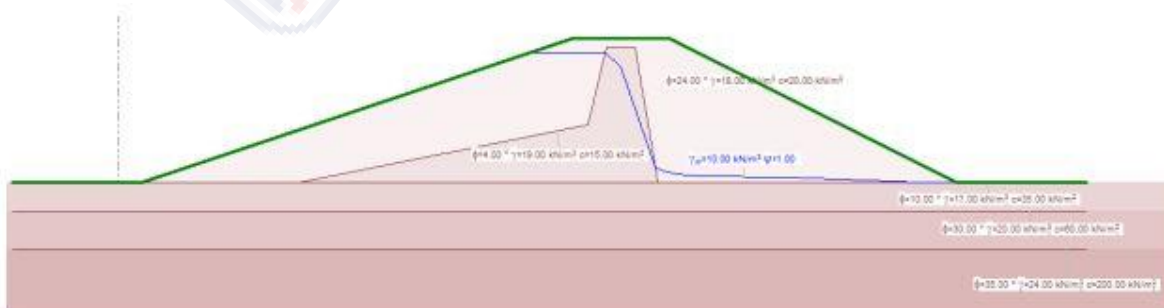
The Bishop technique is used to analyze slope stability. The minimal overall safety stability factor for load case, i.e. when the tank water level drops rapidly, was determined to be 0.50, indicating absolute and imminent failure circumstances. The findings of the computed analysis are depicted in the figures below.
